Client  
Our Lady of the Wayside

Our Ref: Photo Report

Date: 1st September 2017

### **Chimney Inspection Report**

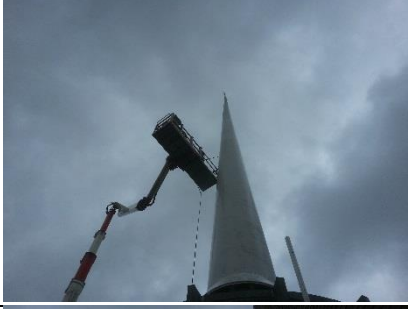
The full external shell was high pressure water jetted to remove all loose paint and traffic build-up
2

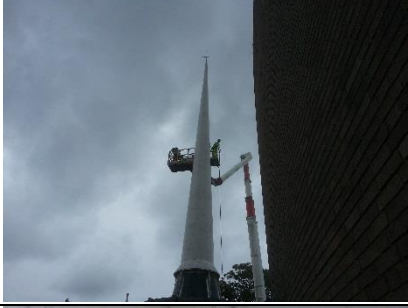
The full external shell was high pressure water jetted to remove all loose paint and traffic build-up
3

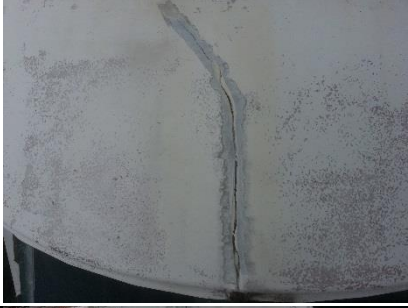
All minor cracks to external shell were ground out and recovered with new fiberglass matting.
4

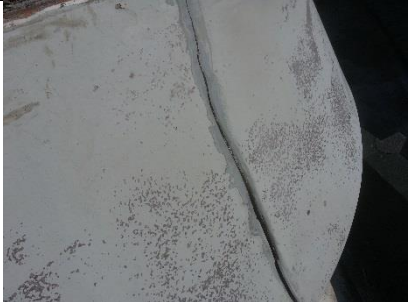
All minor cracks to external shell were ground out and recovered with new fiberglass matting.

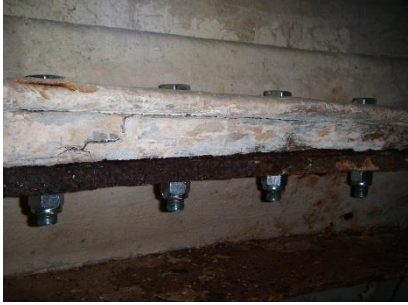
All internal bolts where replaced with new and tightened as the old ones where just hand tight.
6

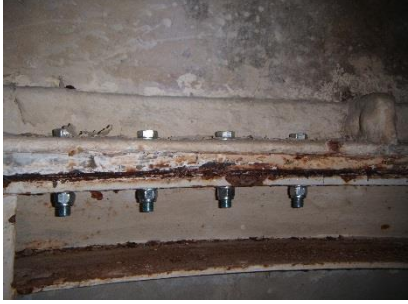
. All internal bolts where replaced with new and tightened as the old ones where just hand tight.
7

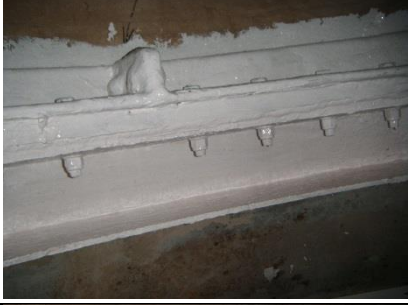
The internal flange was cleaned and treated with stop rust inhibitor and two coats of paint applied
8

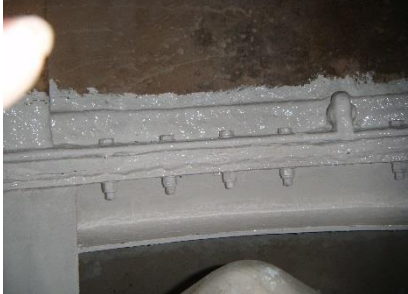
The internal flange was cleaned and treated with stop rust inhibitor and two coats of paint applied

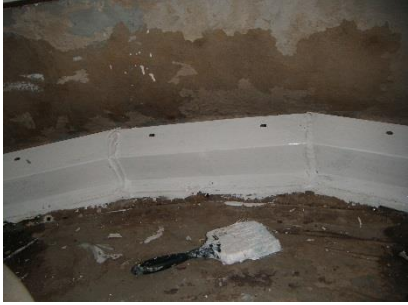
New baffle was cut to size and fitted to prevent water ingress.
10

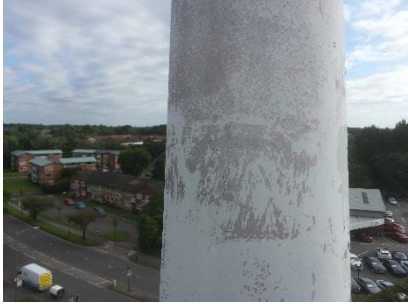
Cleaned external shell before paint application
11

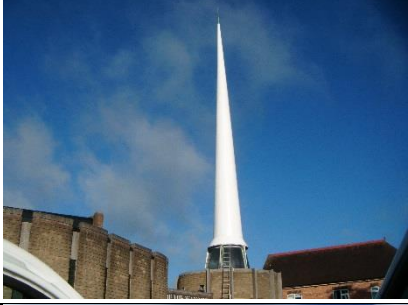
Photo of completed job.
12
