Client  
Our Lady of the Wayside

Our Ref: Photo Report

Date: 1st September 2017

### **Chimney Inspection Report**

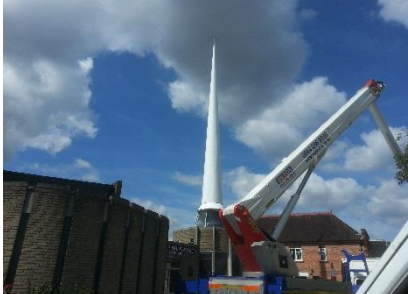
Photo of completed job.
12

**We would recommend that spire is inspected every two years as a minimum of duty of care as the structure requires this due to its age.**
